# ZEISS Microscopes in Restoration and Conservation

## The Imperial Carriage Museum in Vienna, Austria

Authors: Michaela Morelli, Matthias Manzini  
Kunsthistorisches Museum Vienna, Austria

Date: September 2019

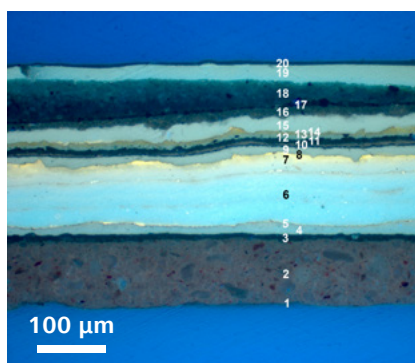
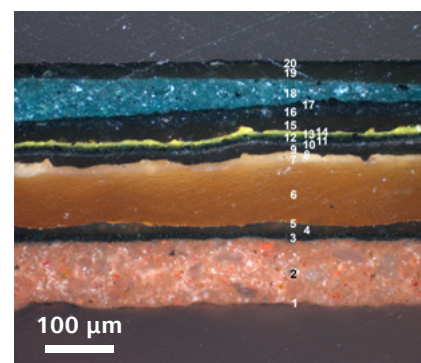
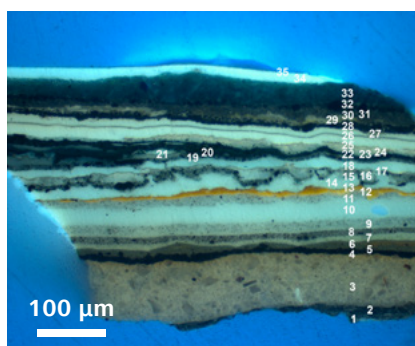
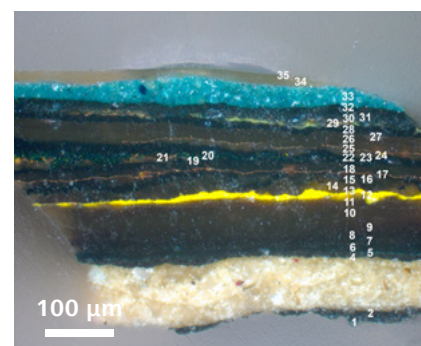
**Image 3** Transverse sections from the outer hoop of a wheel and the outer carriage body. Both under UV light and using differential interference contrast (DIC) it is clear that the wheels and outer carriage body have been painted and gold-plated multiple times. Images at 200 $\times$  magnification kindly provided by S. Stanek of the scientific laboratory at the Kunsthistorisches Museum in Vienna

The details of various layers can be seen in the transverse sections (Image 3). To create a section, a sample of just a few micrometers ( $\mu\text{m}$ ) of material is taken with a scalpel. It is then set in epoxy resin, ground, and analyzed using a light microscope. Up to 37 different layers have already been identified using this method.

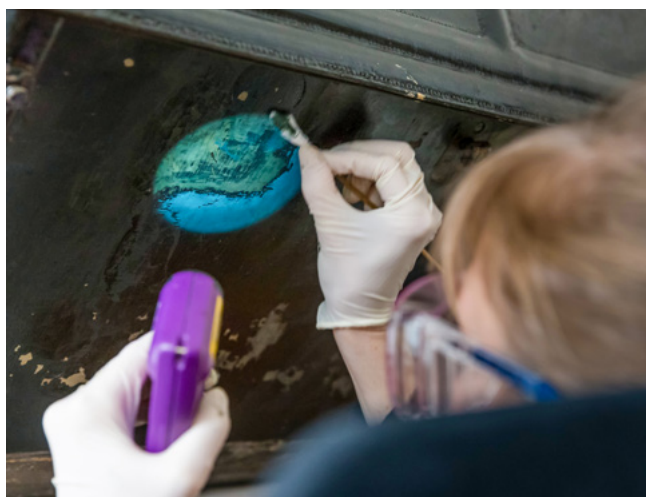
**Image 4** Testing suitable solvents using a UV lamp.

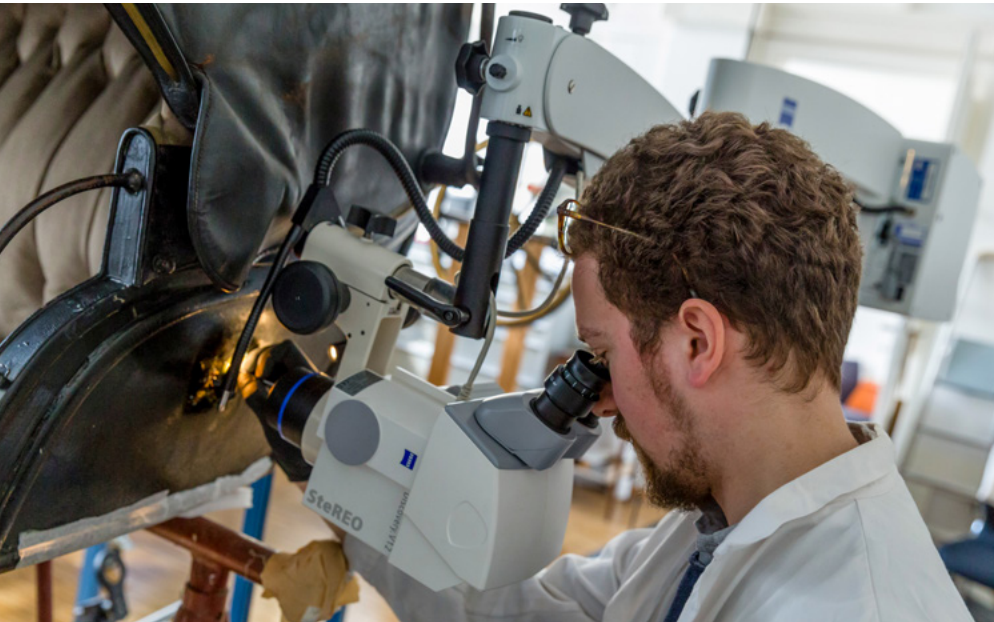
**Image 8** Small cracks and fissures can be easily discerned on the painted surface. These may be caused by aging or by the conflicting movements of different layers. These cracks are also known as craquelure.

When carrying out a restoration, conservators work with a wide variety of materials (Image 7). Textiles, varnish, wood, and metal all require very different analysis and treatment methods. The layers of the craquelure-covered paint surface on one of Franz Joseph I of Austria's coaches – dating back to 1895 (Image 8) – become visible under UV or stereoscopic grazing light as well as with different microscope contrasts. The metal composition (Image 9) of the wheels is determined using electron microscopy and an EDX detector, while fabric fibers (Image 10) are best analyzed using a polarization contrast on a light microscope.

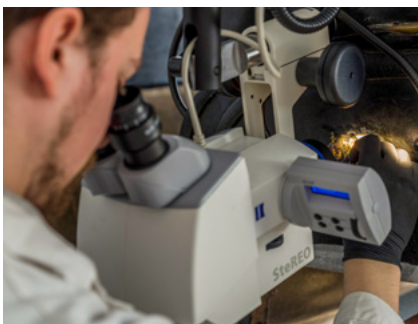
**Images 5 & 6** The ZEISS SteREO Discovery.V8 stereo microscope with a floor stand enables conservators to work sitting down comfortably even with larger objects.

Once a detailed conservation or restoration plan has been created, the real work begins. Step by step, layers are removed using solvents and mechanical removal techniques. More than anything else, this requires patience – time pressure being the enemy of any restoration project. The conservators use a ZEISS SteREO Discovery.V8 stereo microscope with a floor stand (Images 5 & 6). This allows them to work comfortably on large objects like this carriage while sitting

down. The microscope can be accurately adjusted to the exact angle required to direct light to the area being worked on. The conservator uses the ZEISS Axiolab light microscope with polarization contrast to analyze fibers, assess the condition of the material by age, and to document any damage to the clothing caused, for example, by moths. Using the contrast, the conservator is able to differentiate between linen and flax and to pin down the age of a garment.

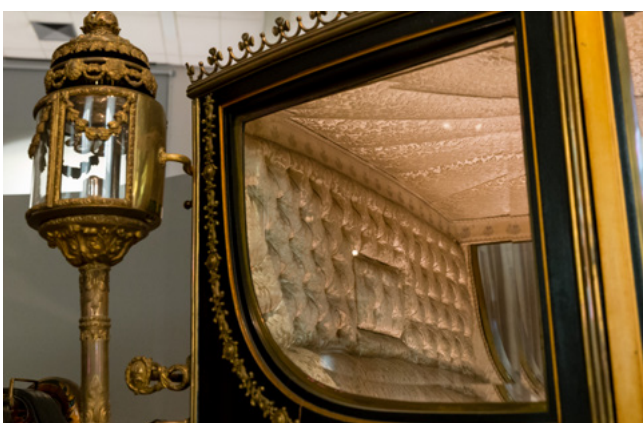
**Image 7** Gilded wooden structures, glass windows, padded interiors, embroideries, metal traction elements, paintings on the wooden elements – a carriage represents the interaction of a wide variety of materials.

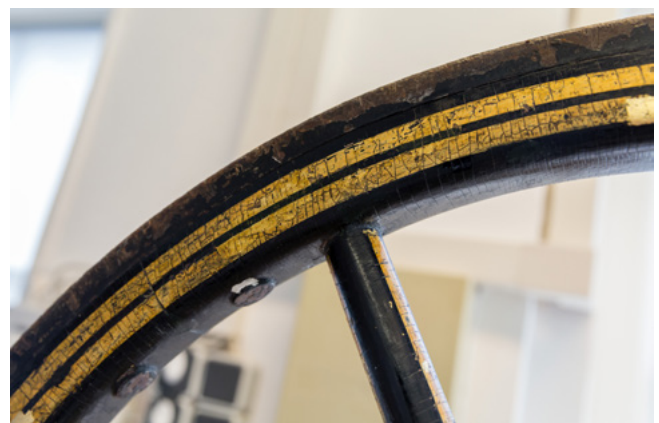
**Image 9** The width of the stripes on the wheels indicated the rank of the carriage's passengers.

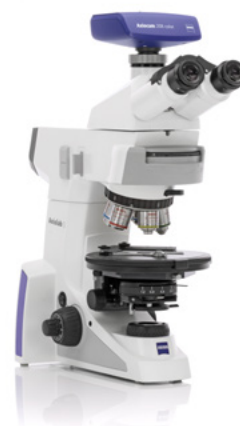
### ZEISS Axiolab 5 with polarization contrast

consequently be taken into account during the restoration. Ideally, this process is carried out using light microscopes featuring polarization contrast. The smallest units of fibers – elementary fibers – are used for this kind of analysis. It is possible to determine the type of fiber on the basis of different optical characteristics. The color of the fiber changes when the microscope stage on the polarized-light microscope is rotated (Herzog test). An elementary fiber may, for example, have a bluish color when viewed from a horizontal position but become a reddish orange when rotated 90°. This is a way of distinguishing synthetic from natural fibers and classifying them.
